Manhole Inspection Summary

Manhole # S15SS1018MH

Insp Date: **10/15/08 9:46 AM**

Location Address: **CLYBURN AVE (SANAI HOSPITAL)**

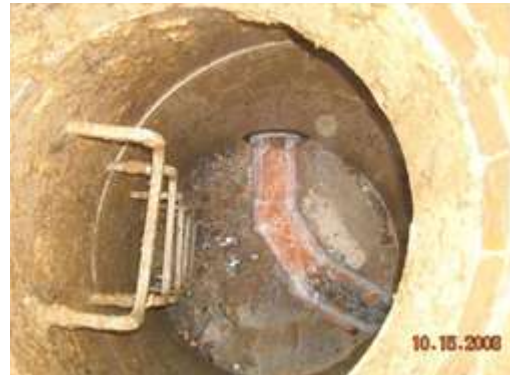
Top View

Bench ☒ Exists Material: **Brick** ☒ Parged ☒ **Debris** (not Condition related)
Condition: ☒ Sound ☐ Cracked ☐ Root Intrusion ☐ Deteriorated ☐ Leaks ☐ Debris

Surcharge ☒ **Evidence Of Surcharge** Depth: **1** (ft.) ☐ Active Surcharge Present

Evidence of surcharge - Bench debris.

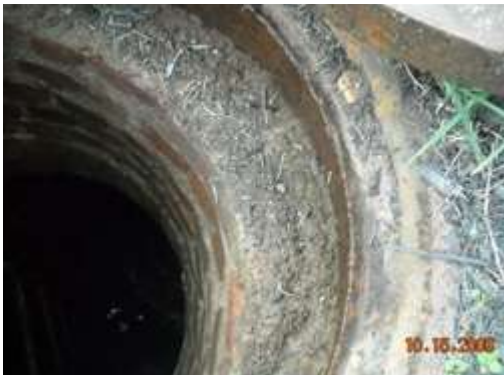
Defect

Frame Offset: **4** (in.) Condition: ☐ Sound ☐ Cracked ☒ **Leaks**

Chimney / Frame Adjustment ☒ Exists Material: **Brick** ☐ Parged Height: **12** (in.)
Condition: ☒ Sound ☐ Cracked ☐ Root Intrusion ☐ Loose Brick ☐ Deteriorated
Infiltration: ☐ None ☒ **Joint** ☐ Cracks ☐ Mortar ☐ Roots ☐ Wall

Frame leaks. Frame offset. Adjustment infiltration.

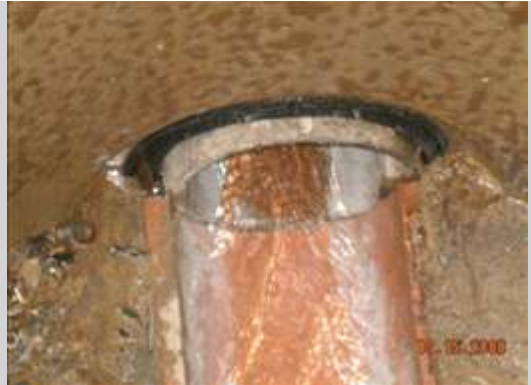
10 in. Circular Gravity Sewer Pipe Out @ 12 O'Clock

Deposits: ☐ None ☐ Mud ☐ Sludge ☐ Debris ☒ **Grease**

Silt Depth: **0** (in.) Deposits Extent: **Light**

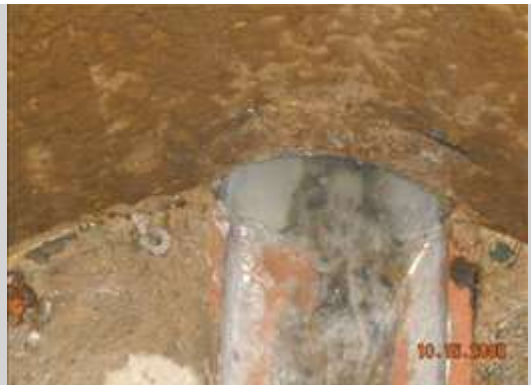
10 in. Circular Gravity Sewer Pipe In @ 4 O'Clock

Deposits: ☐ None ☐ Mud ☐ Sludge ☐ Debris ☒ **Grease**

Silt Depth: **0** (in.) Deposits Extent: **Light**
